# **DAMAGE DEGREE CLASSIFICATION FOR MTR TYPE SPENT FUEL IN WET INTERIM STORAGE**

*10th International Topical Meeting on Research Reactor Fuel Management  
Sofia, Bulgaria. 30 April - 4 May 2006*

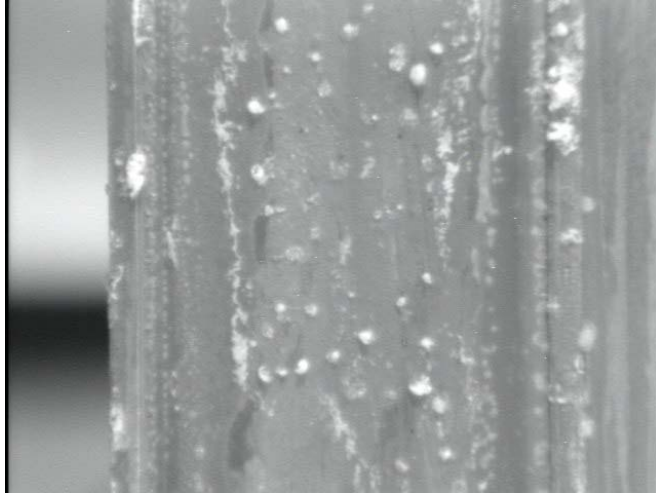
**Pitting on fuel plate active  
zone**

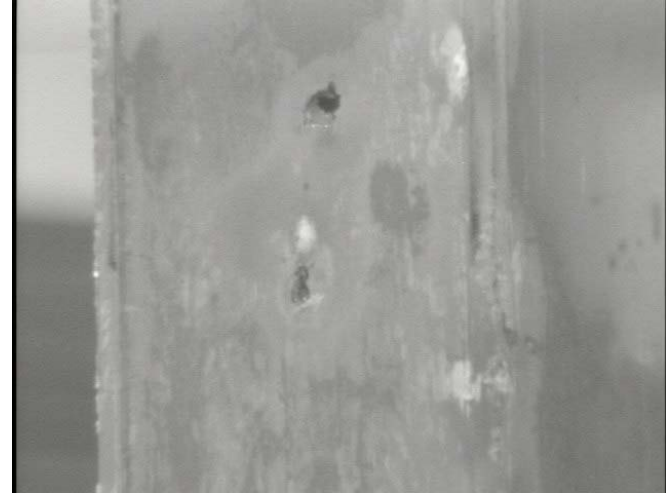
**Corrosion pits with fuel meat  
exposure**

- **Pitting corrosion process so advanced may penetrate aluminum cladding exposing fuel meat**

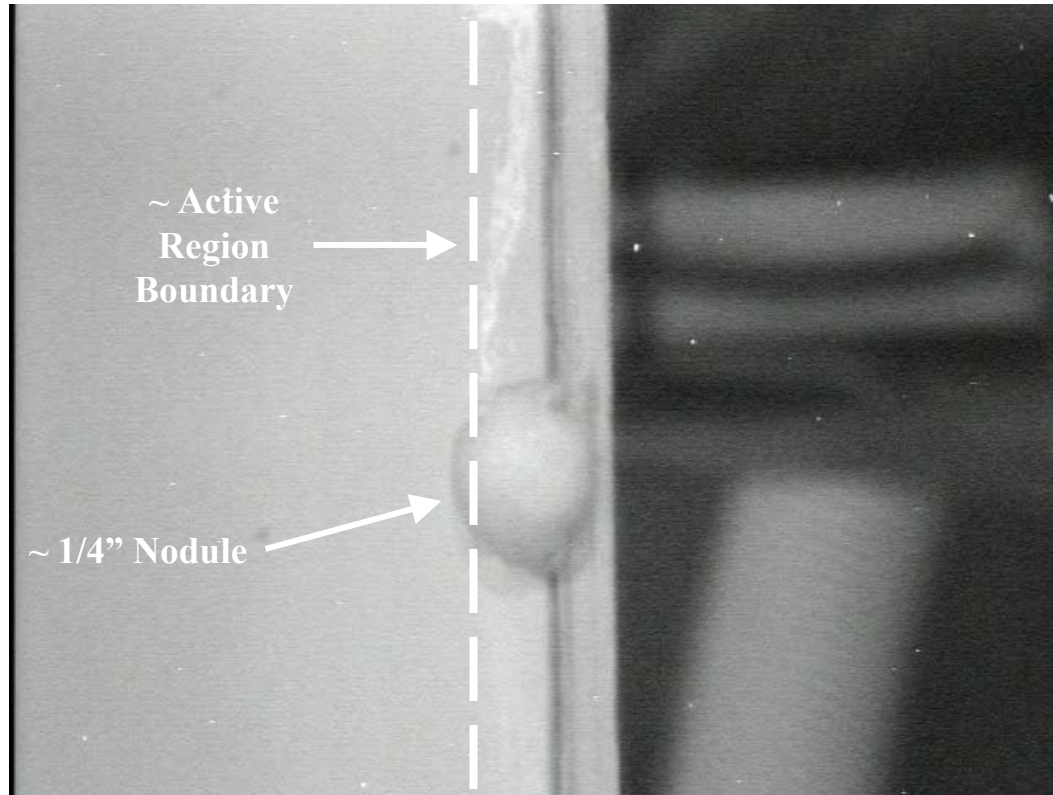
**Crevice nodule of ~ 6 mm that overlaps the active region boundary**

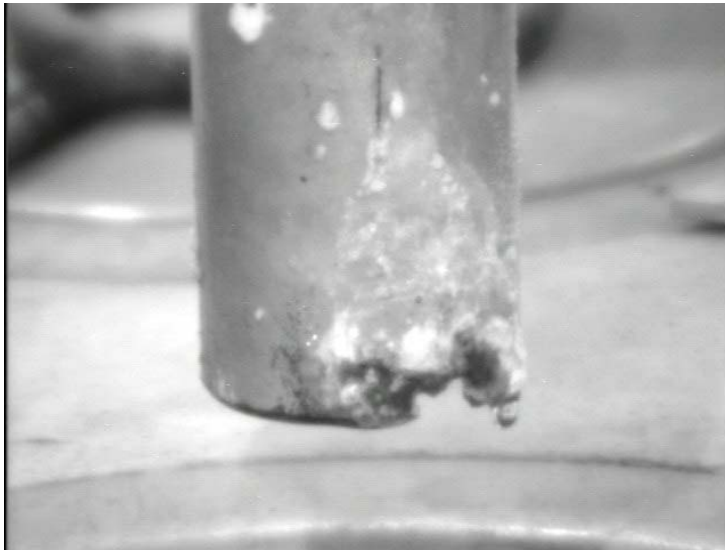
- **Galvanic corrosion due to contact of stainless steel and aluminum in fuel**

**End fitting of fuel assembly  
stored on SS liner tube**

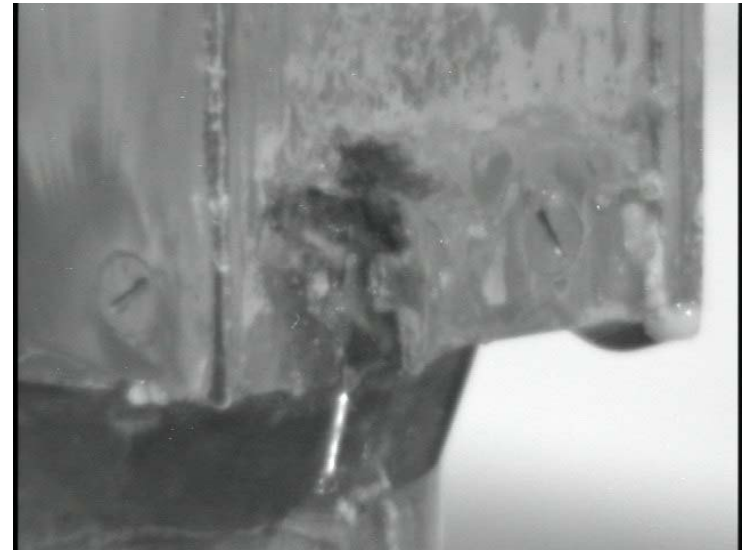
**Degradation of fuel plate. Bulging  
in zone of SS screws**

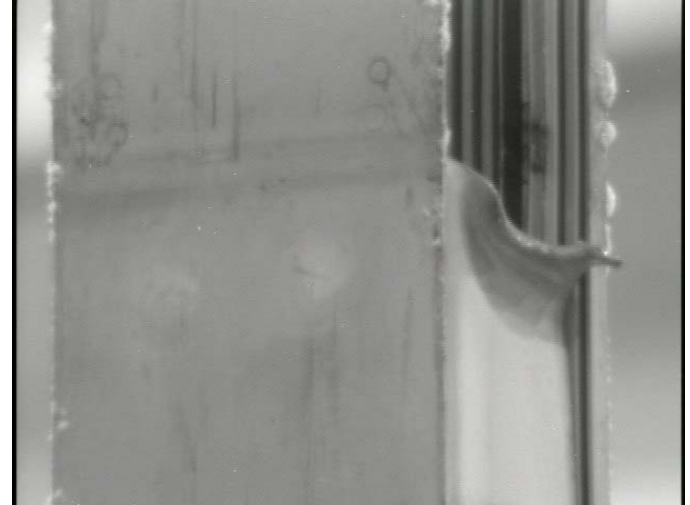
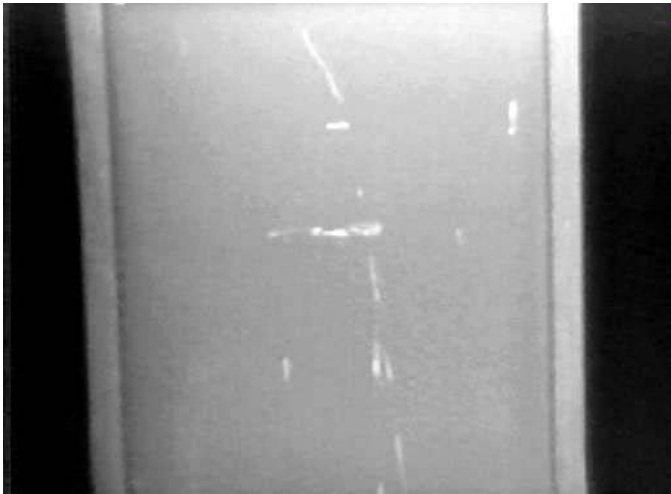
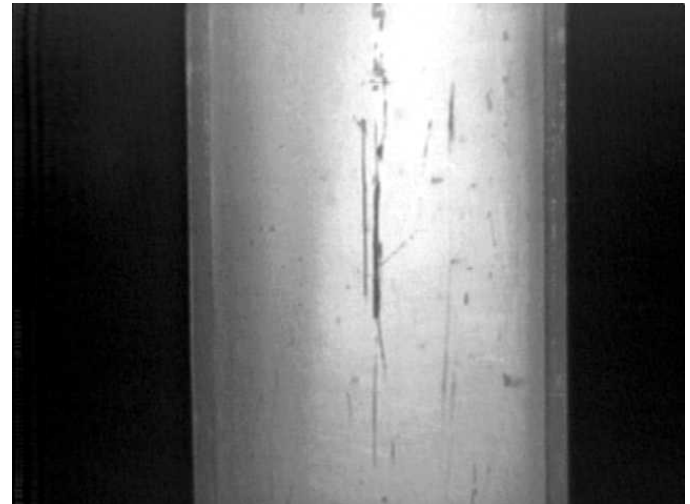
- **Scratching, denting, bending etc.**
- **Harms protective layer of aluminum oxide (boehmite)**
- **Damaged area then becomes preferred area for pitting attack**
- **In extreme cases, inadequate fuel handling can be a direct cause of cladding breaches.**

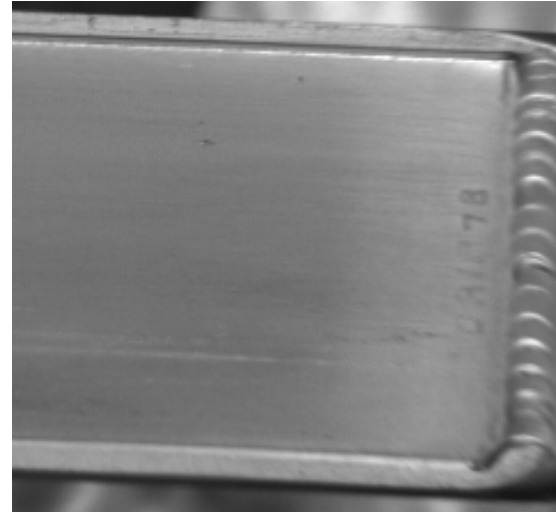
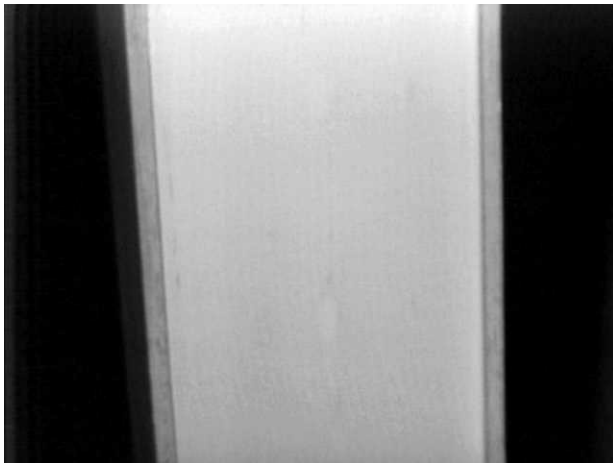
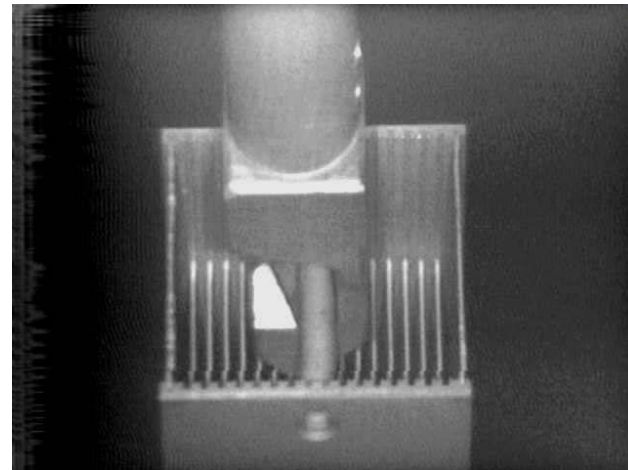
# Damage Degree Classification: Severity Index V0

- **Fuel assembly in good conditions**
- **No general corrosion**
- **No corrosion product nodules**
- **No mechanical damage**

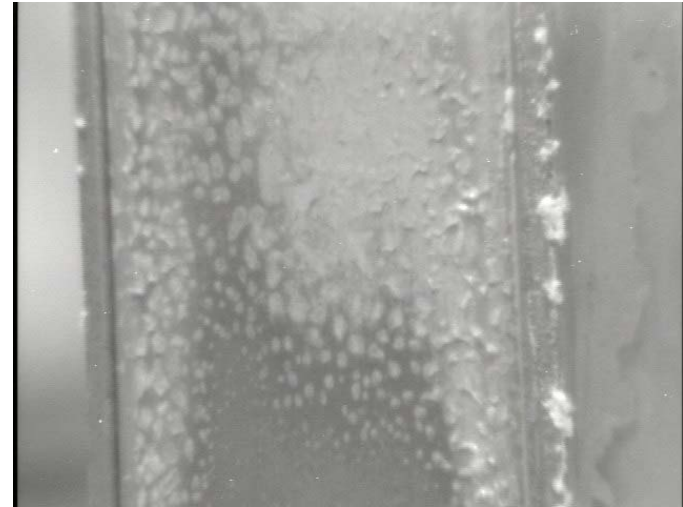
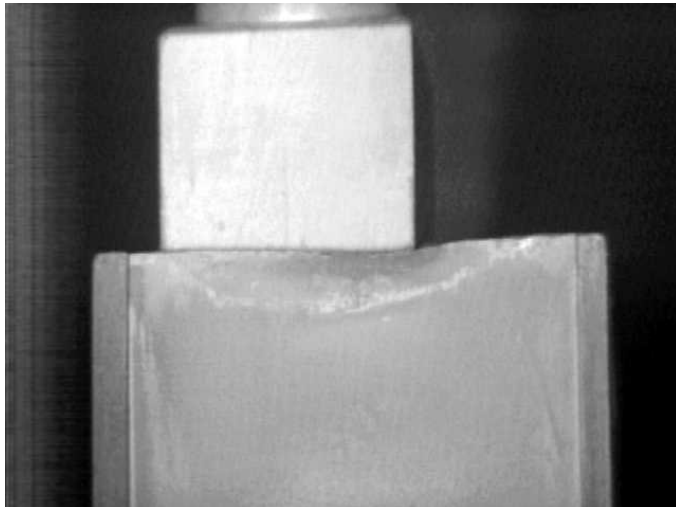
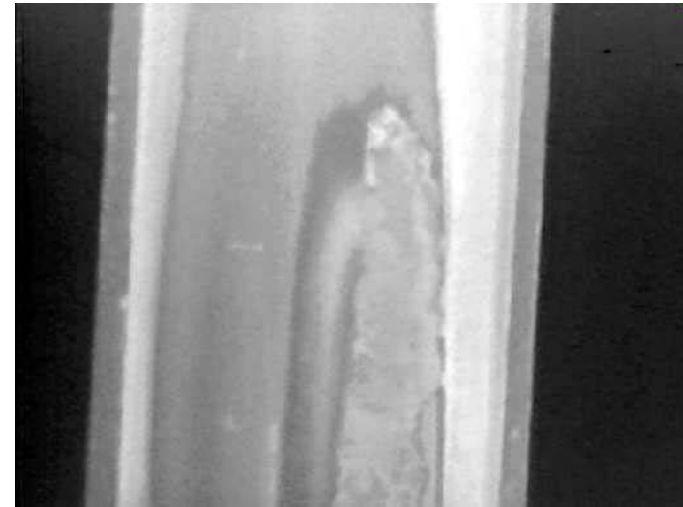
# Damage Degree Classification: Severity Index V1

- **Loss of aluminum oxide layer**
- **Presence of general corrosion**
- **Presence of blisters**
- **Corrosion product nodules**
  - **Nodules < 3 mm in diam.**
  - **No exposition of fuel meat**
- **Mechanical damage out of active region**

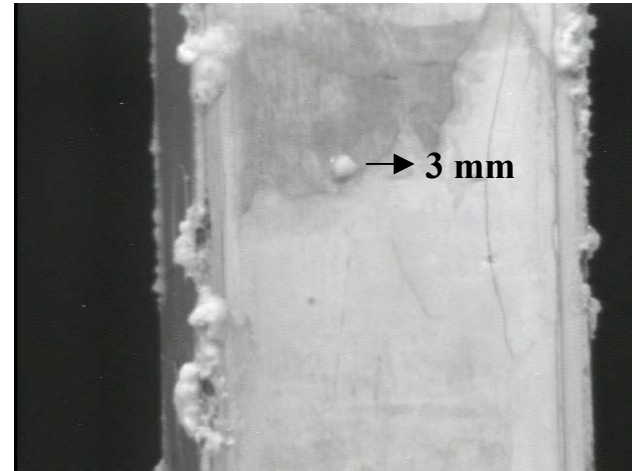
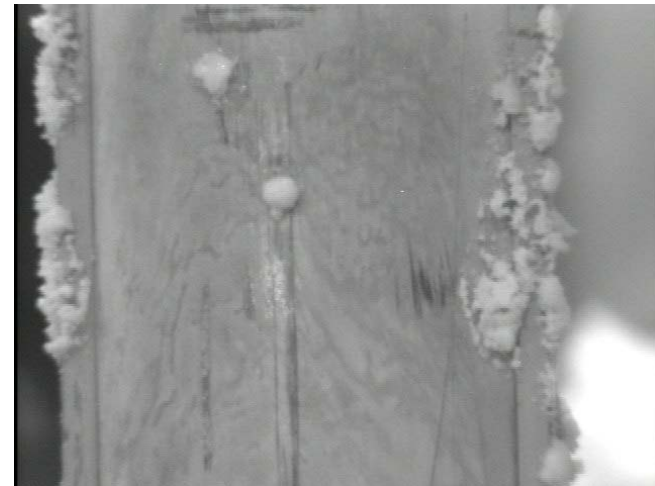
# Damage Degree Classification: Severity Index V2

- **i) Corrosion product nodules with estimated fuel meat exposure**
  - **Nodules  $\geq 3$  mm in diam.***and/or*
- **ii) Corrosion pits with fuel meat exposure**
- **Exposed meat for i) + ii)  $< 0,5$  cm<sup>2</sup>**  
*and/or*
- **Mechanical damage at active region with cladding deformation**

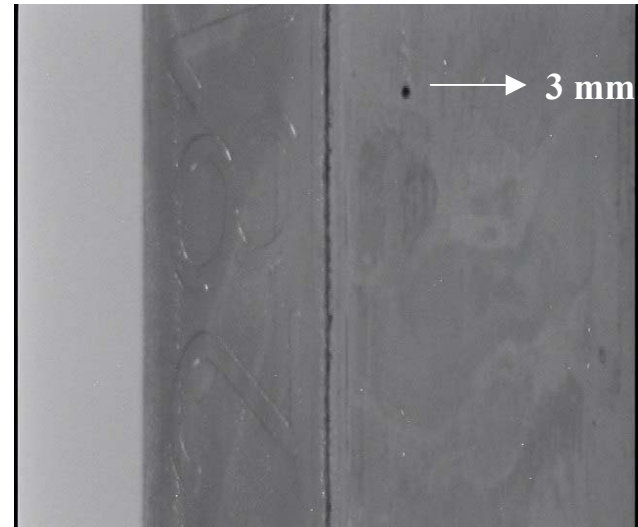
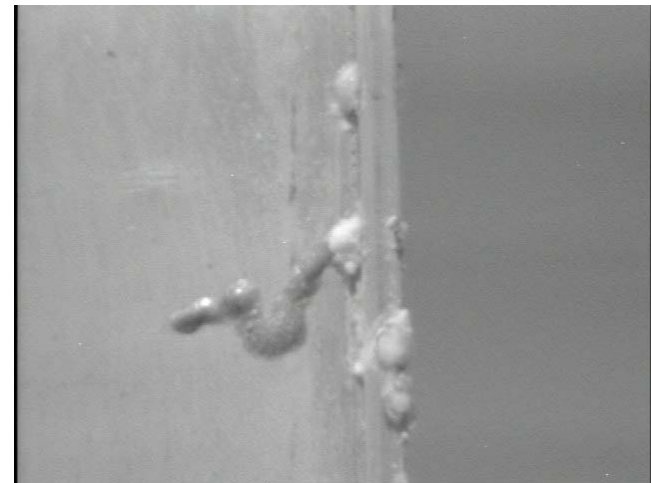
# Damage Degree Classification: Severity Index V3

- **i) Corrosion product nodules with estimated fuel meat exposure**  
*and/or*
- **ii) Corrosion pits with fuel meat exposure**
- **Exposed meat for i) + ii)  $> 0,5 \text{ cm}^2$  but  $< 1,0 \text{ cm}^2$**   
*and/or*
- **Mechanical damage at active region with possible cladding penetration**

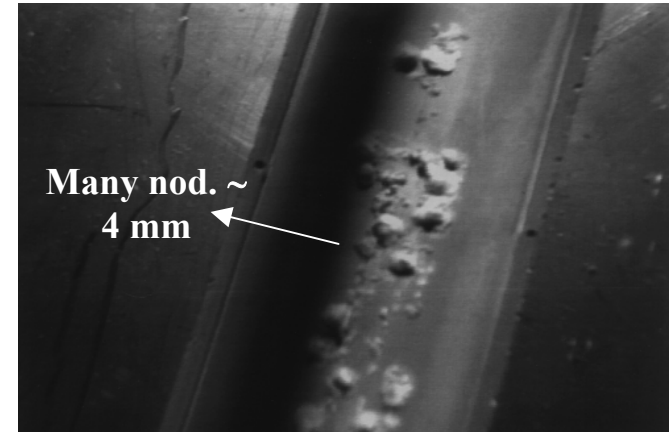
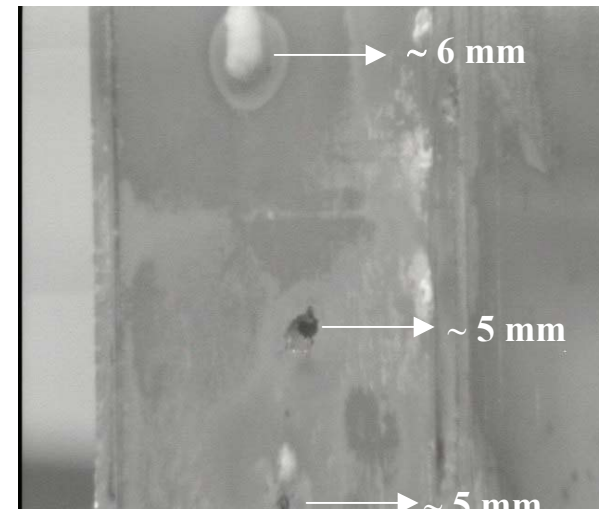
# Damage Degree Classification: Severity Index V4

- i) Corrosion product nodules with estimated fuel meat exposure  
*and/or*
- ii) Corrosion pits with fuel meat exposure  
*and/or*
- iii) Mechanical damage at active region with cladding penetration
- Exposed fuel meat for i) + ii) + iii)  $\geq 1 \text{ cm}^2$   
*and/or*
- Any damage potentially significant to structural integrity of fuel assembly
