# **DAMAGE DEGREE CLASSIFICATION FOR MTR TYPE SPENT FUEL IN WET INTERIM STORAGE**

*10th International Topical Meeting on Research Reactor Fuel Management  
Sofia, Bulgaria. 30 April - 4 May 2006*

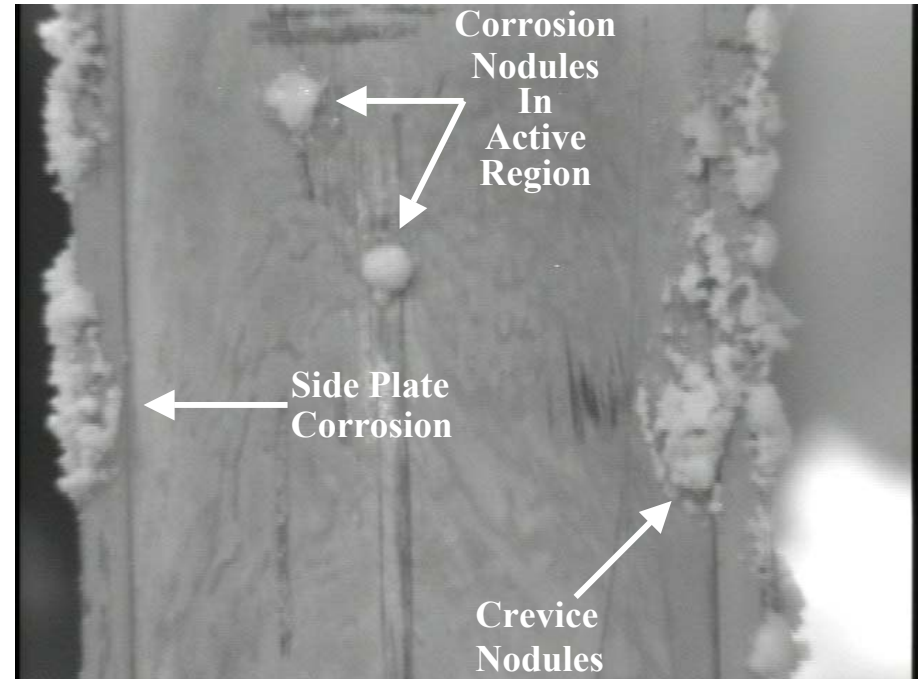
# Corrosion Damage

- **Principal cause of fuel degradation while in interim wet storage**
- **Increased by storage with very poor water quality**
- **Present mainly in the form of aluminum oxide nodules on fuel plates and lateral plates**
- **Typically, nodules are consequence of mechanisms such as “pitting” and “crevice corrosion”**
- **Side plate corners sensible to corrosion attack**
